The Tankship Tromedy

**The Impending Disasters in
Tankers**

Jack Devanney
Sisyphus Beach
Tavernier, Florida

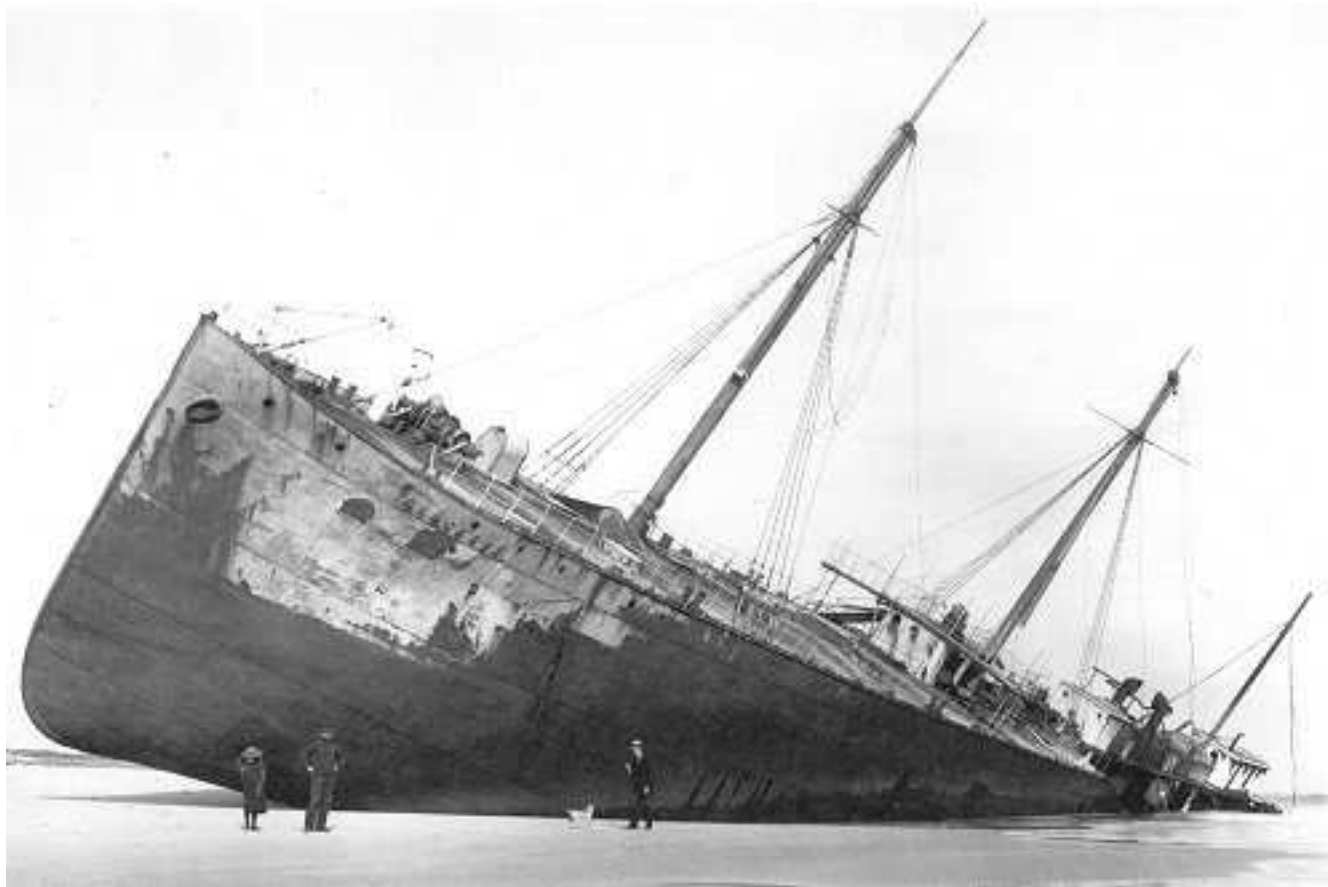
Figure 2.1: Glückauf stranded on Fire Island, 1893. No modern tanker would still be intact in this situation.
Source: Long Island Maritime Museum.

⁵ All normal cargo ships have double bottoms. On the Glückauf this was eliminated to avoid explosions resulting from cargo leaking into the double bottom space.

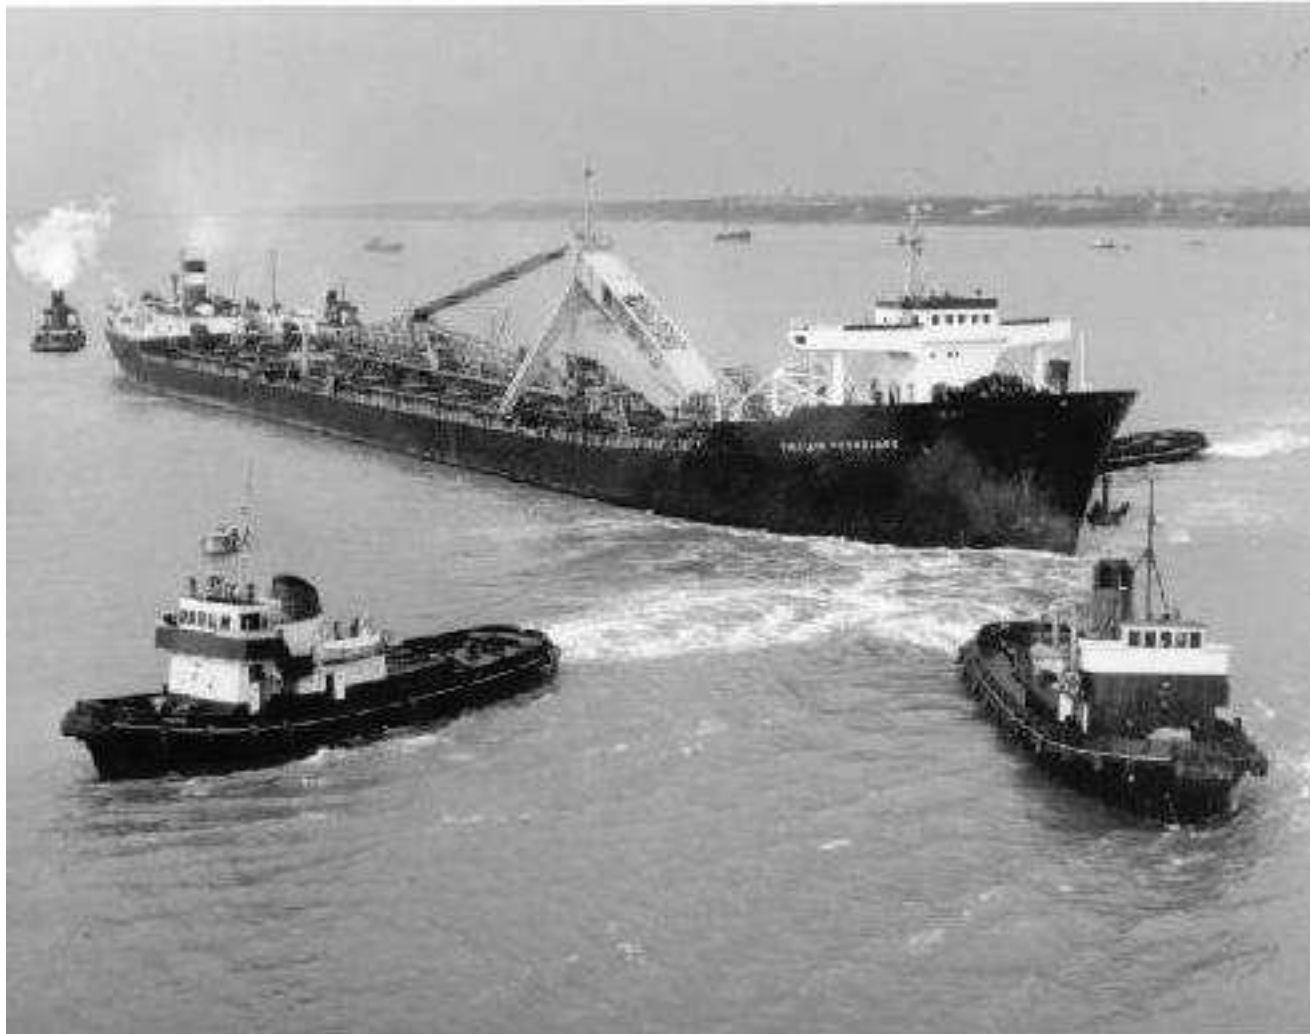
Figure 2.2: Sinclair Petrolore: Self-Unloading Ore-Oil Carrier. Source: www.solentwaters.co.uk

¹¹ The SINCLAIR PETROLORE, Figure 2.2, was truly unique; not only the biggest ship in the world but a self-unloading ore/oiler. The world has never seen anything like her before or since. In 1960, she exploded off Brazil spilling 60 million liters. This was the largest oil spill ever at the time by at least a factor of two. Most likely cause was cargo leaking into the double bottom.

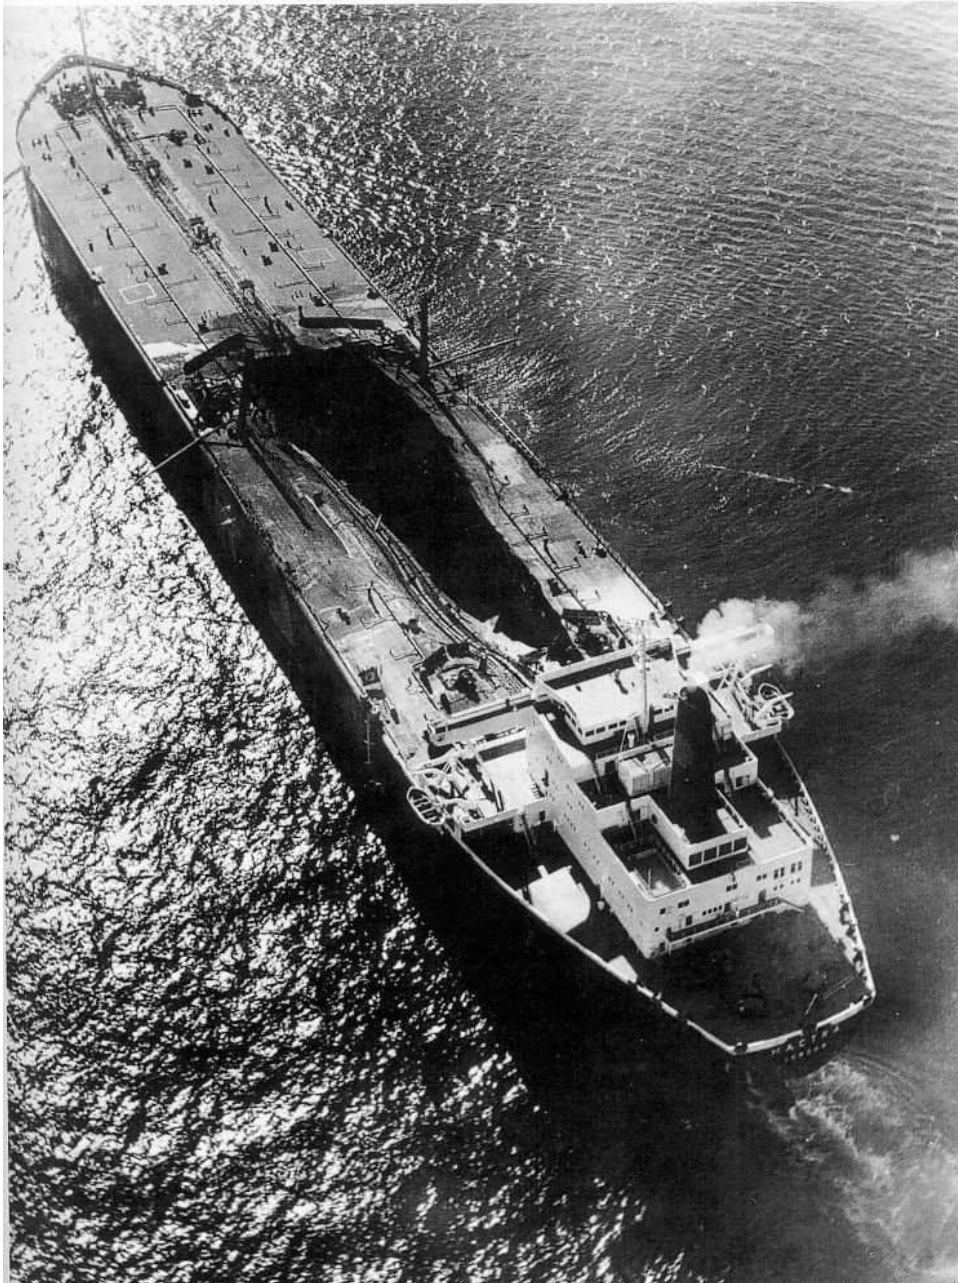
Figure 2.4: Mactra deck after tank cleaning explosion. Two killed.
Source: Auke Visser, supertankers.topcities.com

Cargo tank cleaning is accomplished by machines that look like and work like enormous lawn sprinklers. These gadgets shoot a revolving high pressure jet of sea water around the tank, in theory blasting the surfaces clean of oil. Two of the tankers involved, the MARPESSA and the MACTRA were Shell ships. The third was the brand new KONG HAAKON VII. The MARPESSA, on her maiden ballast leg, sank killing two crewmen. The MACTRA, Figure 2.4, and the KONG HAAKON VII, Figure 2.5, had a large portion of their main decks blown away but survived.

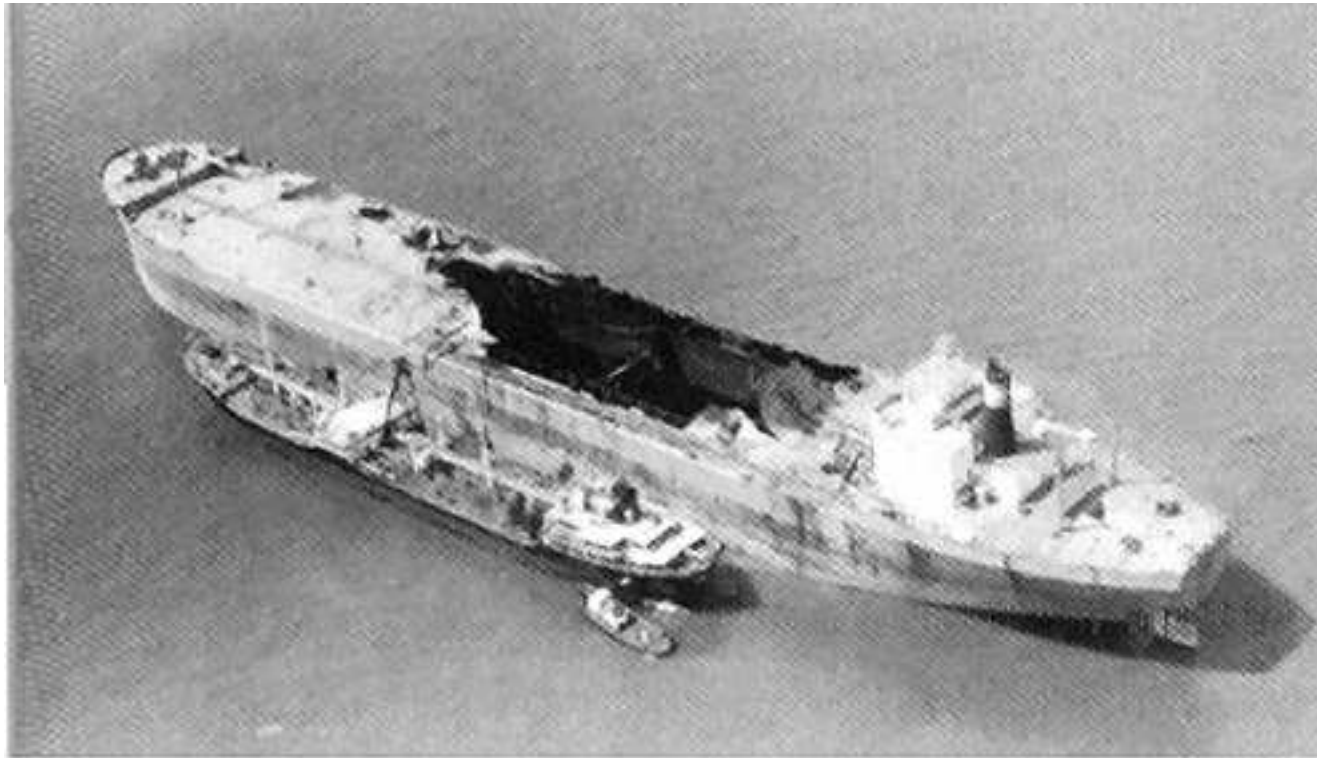
Figure 2.5: Kong Haakon deck after tank cleaning explosion. Obvious similarity to Mactra. Source: Auke Visser, supertankers.topcities.com

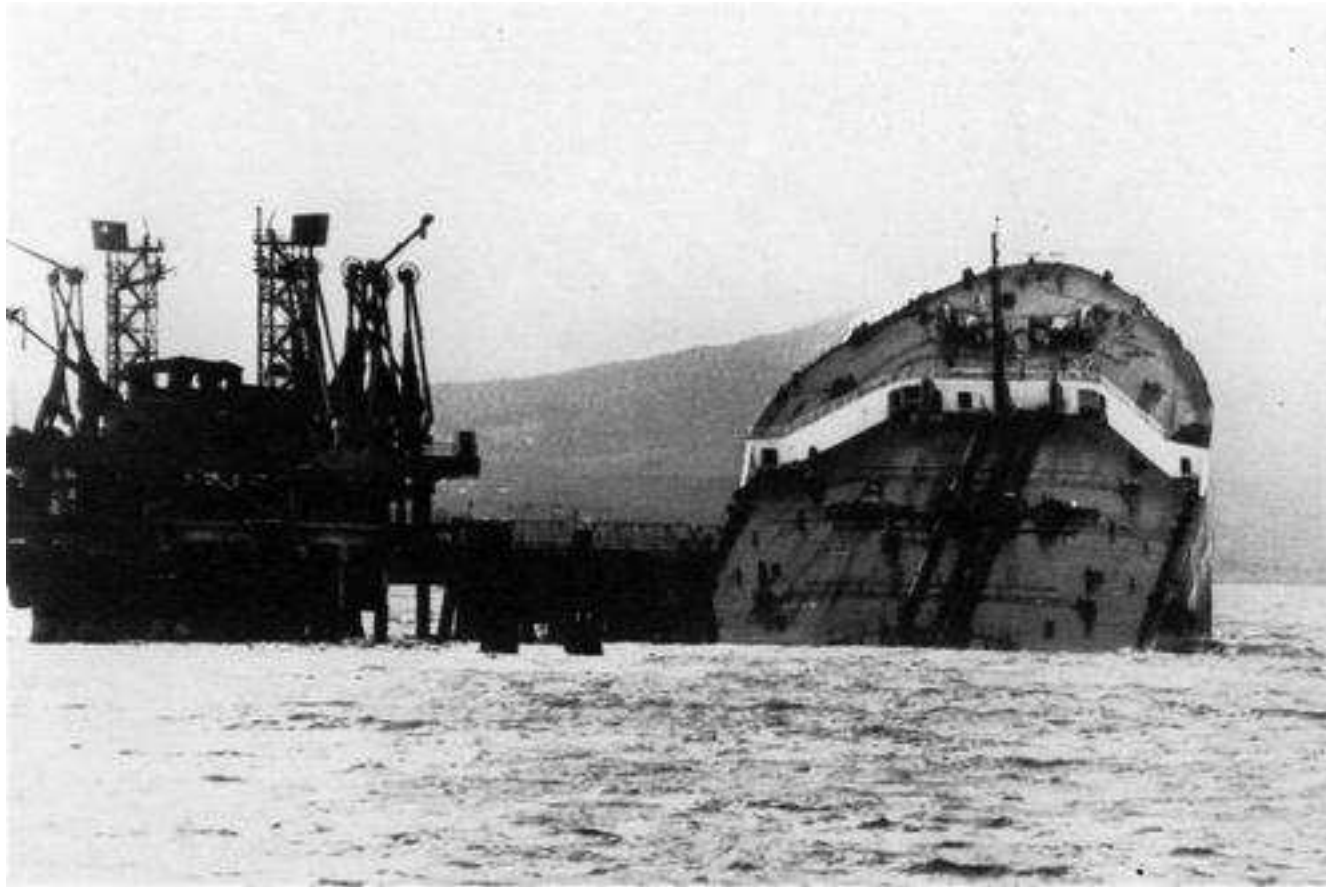
Figure 2.6: The Betelgeuse at Whiddy Island. Horribly corroded segregated ballast tanks. Uninerted. Fully Class Approved. 50 dead. Source: Auke Visser, supertankers.topcities.com

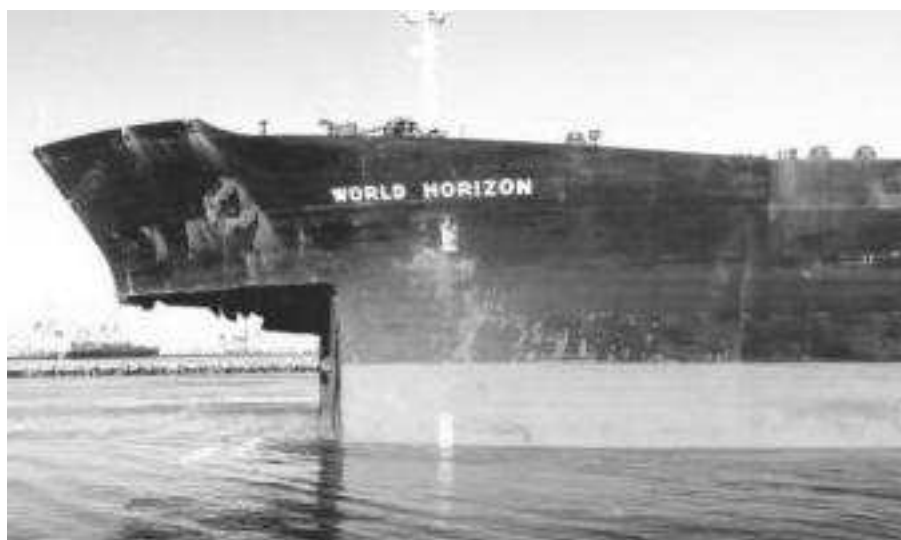
Figure 2.8: World Horizon after “freak wave” removed forepeak tank. This wave was able to excise only the forepeak tank with almost surgical precision. The true cause was that this segregated ballast tank was very badly corroded. The surrounding spaces were not. Spill was about 850 kiloliters. Source: University of Capetown.

We also started seeing big failures in the forepeak tank, the other segregated ballast tank in a pre-Marpol tanker. In several of these cases, the forepeak tank simply fell off. Examples include the WORLD HORIZON, Figure 2.8, the GALP FUNCHAL, the TOCHAL, Figure 2.9 and the ENERGY ENDURANCE

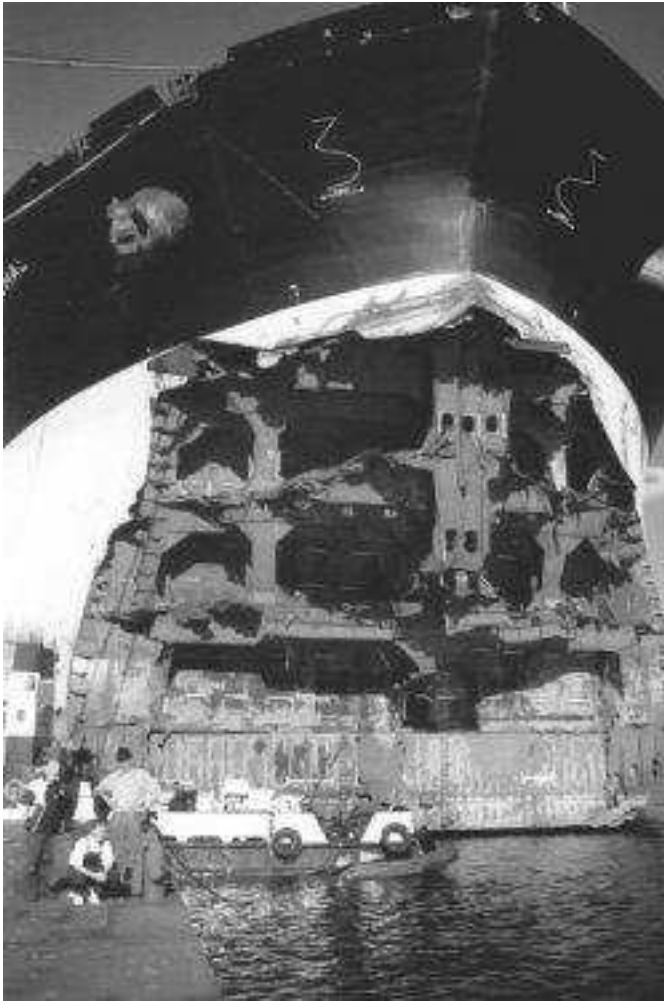
Figure 2.9: Tochal sans forepeak tank. The cut is not quite as clean as the World Horizon, but the boundaries of the forepeak tank are clearly visible. And this picture gives a better view of the forepeak tank corrosion. The ship was towed stern first into False Bay and lightered. About two hundred kiloliters of fuel oil was spilled from the forward bunker tank. Without a port of refuge, this could easily have been a 300 million liter spill. The Tochal was fully approved by her Classification Society. Source: University of Capetown.

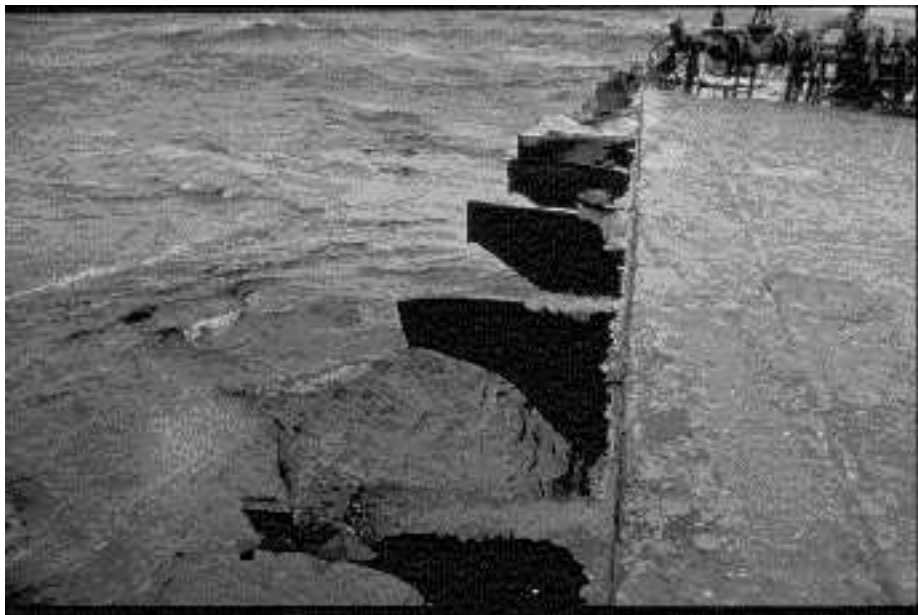
Figure 2.10: Kirki sans forepeak tank. Once again fairly sharp cut at aft end of forepeak tank. Deck had become wafer thin forward of this point. Source: Australian Maritime Safety Authority.

The KIRKI is the best documented example of a vanishing forepeak tank. In 1991, this ship ran into bad weather off Western Australia, while loaded with a volatile crude. The forepeak ballast tank was horribly corroded. The hull structure failed on deck at the bulkhead between the forepeak tank and the forwardmost cargo tanks. The combination of hydrocarbon vapor escaping from the cargo tanks and the loose steel banging around started a fire, which was then put out by the sea. This process was repeated several times until the whole Forepeak tank just fell off, Figure 2.10

in order. She was nicely painted. Yet when the Australians inspected this ship, they found massive corrosion not only in what was left of the forepeak, Figure 2.10, but in the aft segregated ballast tanks as well.³⁸ They found rust camouflaged with canvas. And they found the ship's safety gear, and some of machinery including the boiler safety valves in horrible condition. The Australians were at a loss to explain how the ship's Classification Society could have missed all this. Germanischer Lloyd for its part blamed "poor cooperation" on the part of the owner, Thenamaris.³⁹ In fact, owner and Class had developed the normal close working relationship.

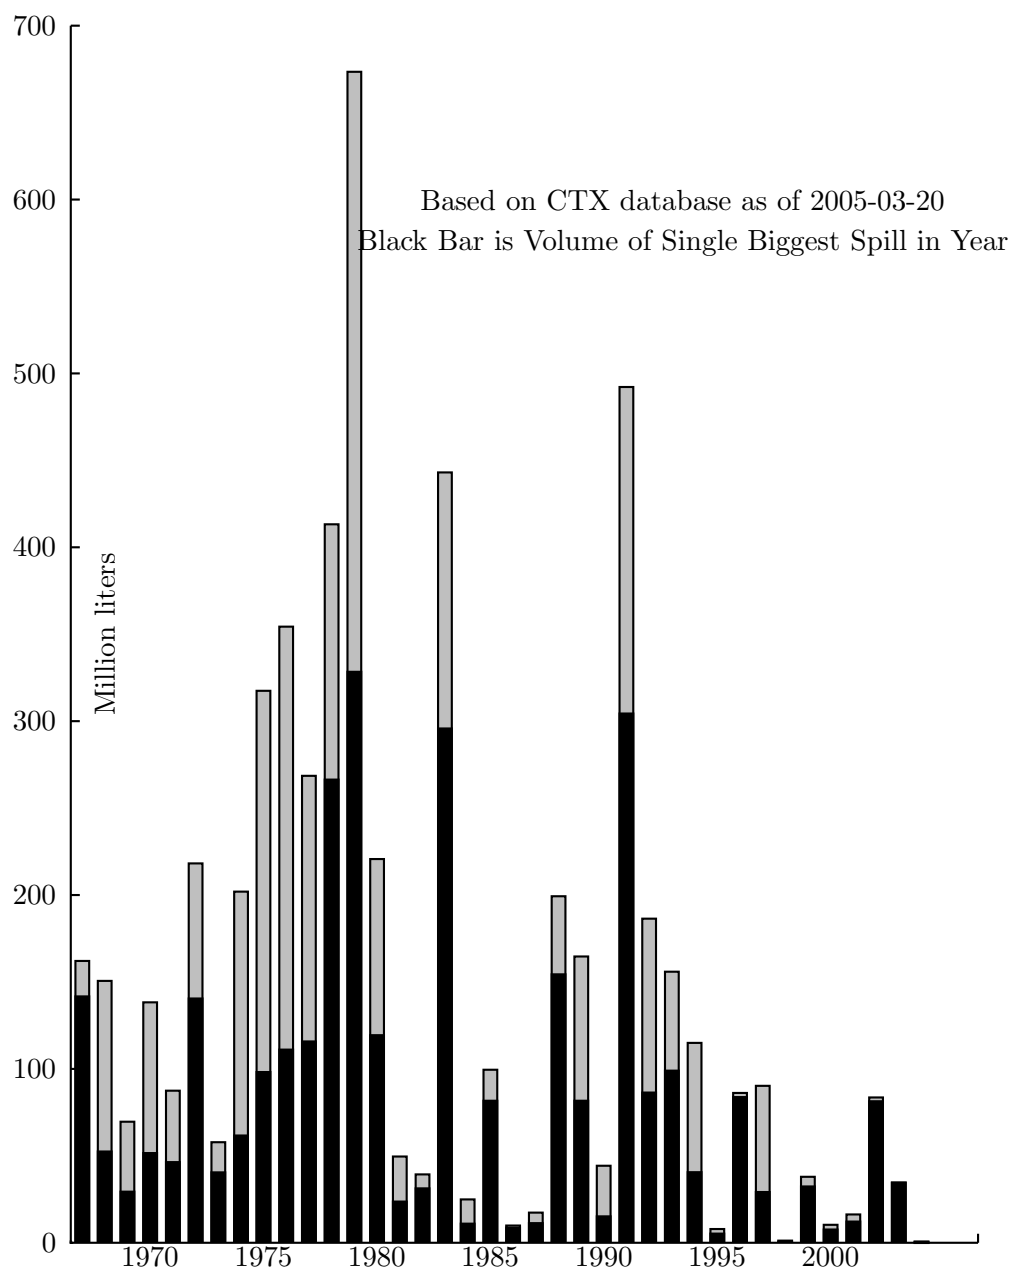
Figure 3.1: Annual versus Biggest Spill by Year

Actually the performance of the last five years is fairly typical of the post-Exxon Valdez era and not much better than the middle 1980's. See Figure 3.1. Stretches of several years between high-profile spills are common.

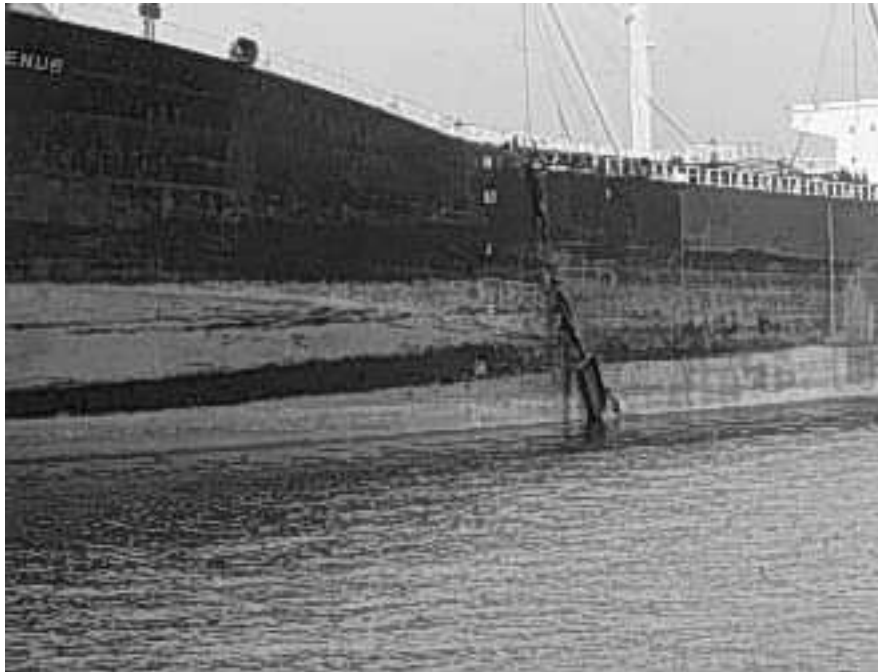
Figure 3.3: Alvenus buckled after grounding. Source: R. Hann.

⁷⁶ The ALVENUS is an example of a grounding in which we can be confident a double bottom would not have helped. The ALVENUS hit the sea bottom in a manner that the bow was pushed up. The main deck split open forward with the rupture extending down to the waterline on either side. See Figures 3.3 and 3.4. The ship's single bottom was never penetrated. Paik has shown that modern double hulls are very weak when it come to deck buckling.[69]

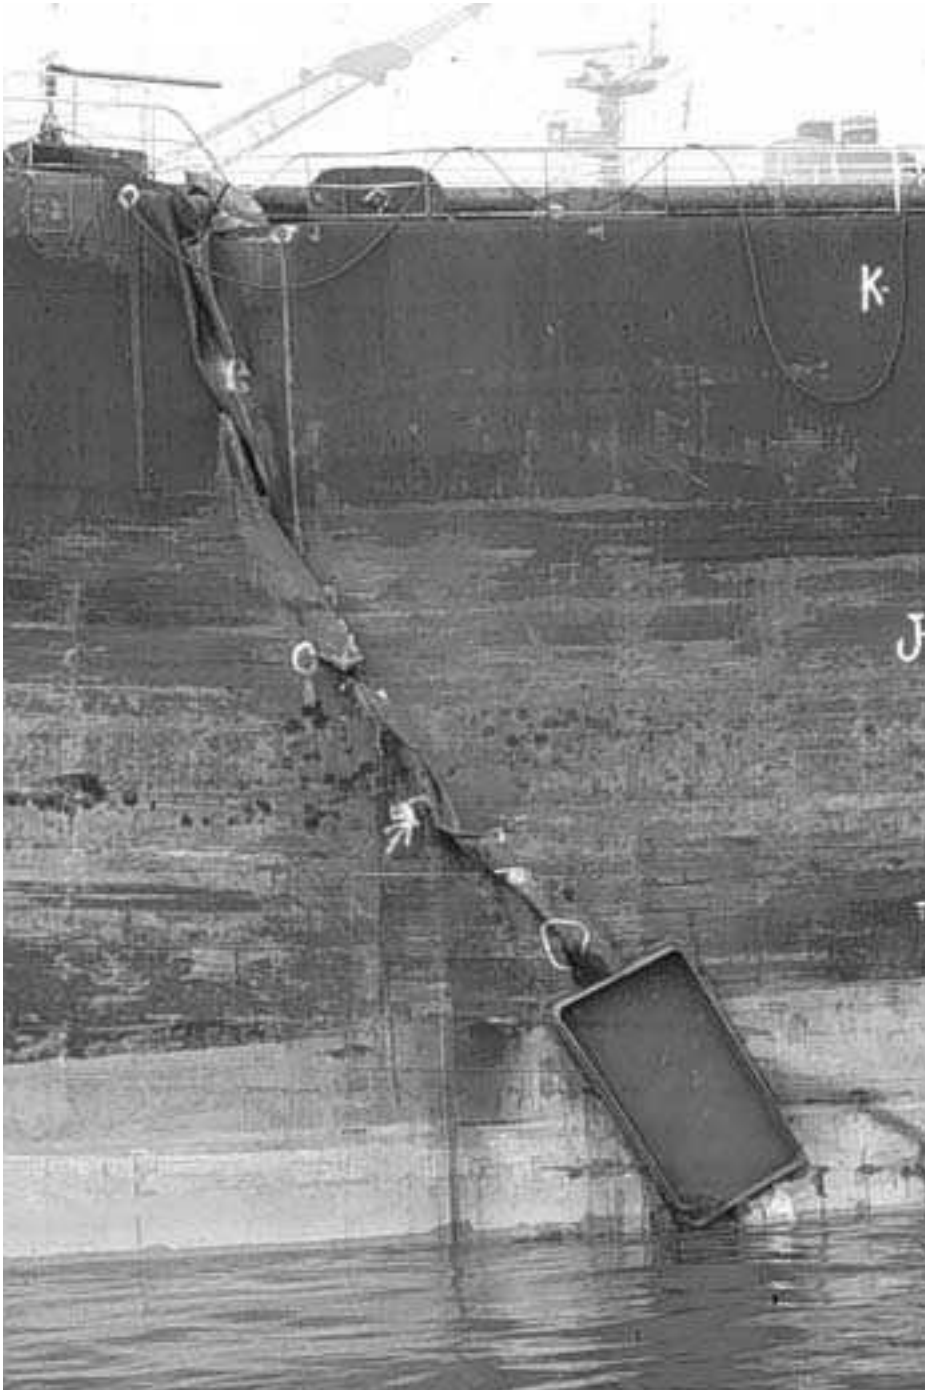
Figure 3.4: Alvenus fracture extended down to waterline. Source: R. Hann.

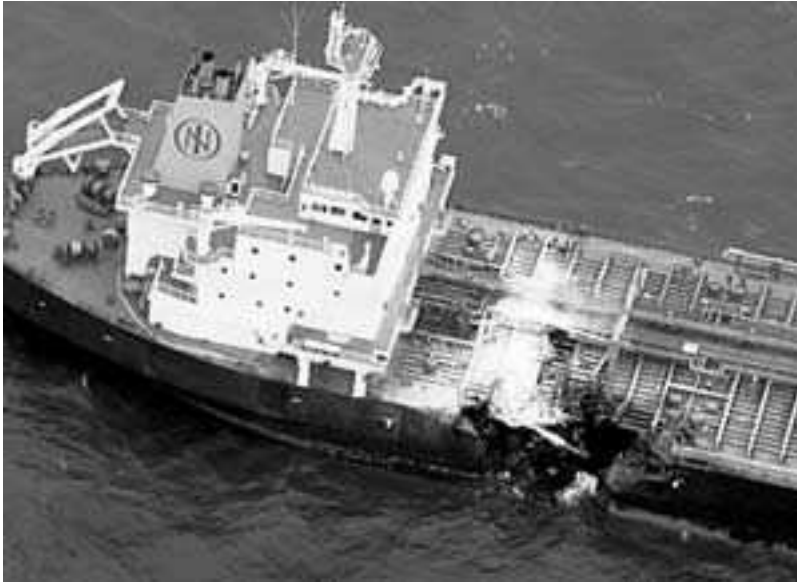
Figure 3.5: Helo view of double hull Baltic Carrier. Source: DR.

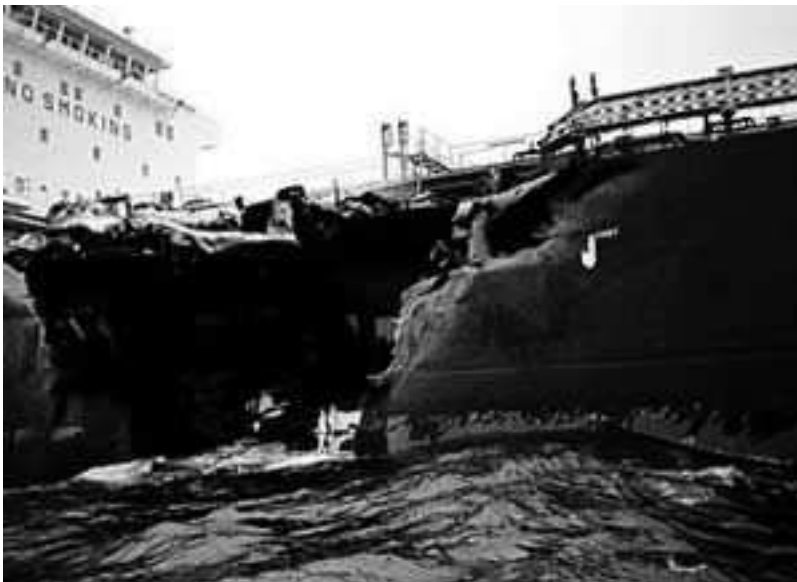
Figure 3.6: Close up view of Baltic Carrier penetration. Source: DR.

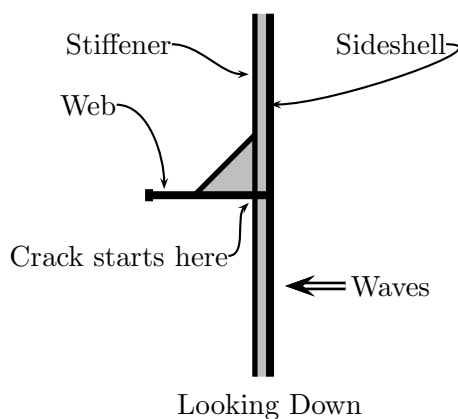
Figure 4.2: Design for Producability

It also created a big hinge. Figure 4.2 looks down on this design. On the forward side of the web, the structure was very rigid. On the aft side, the shell plating was free to flex back and forth with the wave action. Think of the forward side of the web as the lip of the coffee can; the aft side as the lid. Not surprisingly it wasn't long before cracks started appearing on the inside edge of the shell stiffeners just behind the web, and only a matter of time after that that the crack would work its way thru the stiffener out to the shell.

is that there is nothing subtle about this error. You don't have to be as structural engineer to know that Figure 4.2 is a terrible design. So why did the ship's Class, Lloyds, approve it? You will have to ask the Tromedy. All I know is that you will see the same kind of lousy design just about wherever you look in a modern tanker.

When we reactivated the *Enterprise* in 1985, we installed soft-nosed backing brackets on the aft side of the web to balance the brackets on the forward side. This eliminated the hinge, and we had no more cracks in this area. Unfortunately the *Enterprise* only traded for seven months before she was exoceted by the Iraqis in the Iran-Iraq War. The whole engine room was destroyed. No one was hurt. But the ship was a total loss. My guess is that, if we had been able to keep her, cracks would have shown up somewhere else. The structure was just too weak and too ugly.

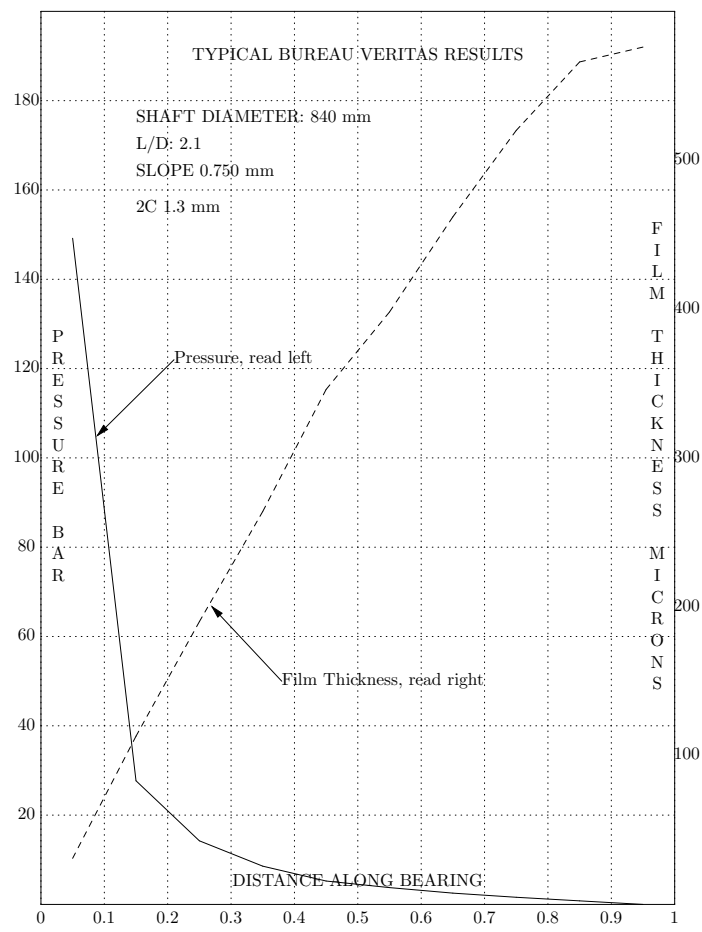
Figure 5.1: Sterntube bearing pressure and oil film thickness

Figure 5.1 is the reason why the composite bearings failed immediately while the white metal bearings have taken longer. There is only one area where white metal bearings are better than composite; but in that area they are far better. That area is heat conductivity. The conductivity of white metal is over 30 times higher than that of the composite material. The composite bearing relies on the lubricating fluid to conduct away the 7.5 KW of heat generated in a VLCC stern tube bearing. But most of that heat is generated in the high pressure portion of the bearing where the film thickness is much too thin to do the job. The composite bearing burns out almost immediately. White metal has a great deal more ability to conduct

FIGURE 13.1 AFT STERN TUBE BEARING PRESSURE AND FILM THICKNESS

the heat away itself, so there is no immediate burn out despite the thin film thickness. But that doesn't change the fact that the pressures are very high, in fact far above the yield point of the white metal. Rapid wear down will occur, and premature failure is inevitable. We will see a lot of VLCC's dead in the water due to bearing failures. The only real question is: how many will drift ashore?³⁴

There are no Class restrictions on shaft bending within the bearing. However, there is one Class that has the capability to study at least a part of this problem. Bureau Veritas (BV) has a program which has the ability to model bending within the bearing and determine the resulting pressure distribution and oil film thicknesses within the bearing. Figure 5.1 shows a typical result. Figure 5.1 is based on an alignment that was acceptable to Class on the grounds that the misalignment at the aft end of the bearing was small ($1.0\text{e-}4$ radians) and the nominal pressure (bearing load versus overall bearing area) was a reasonably conservative 6.3 bar, well below the Class limit of 9.0 bar. But what counts is the distribution of the pressure within the bearing and the standard Class approved method simply cannot address that issue. In this case, the BV results show the pressure on the aft 10% of the bearing averages 140 bar, well over BV's recommended (and none too conservative) maximum of 100 bar. At this pressure, the lubricating film thickness is a miniscule 31 microns.

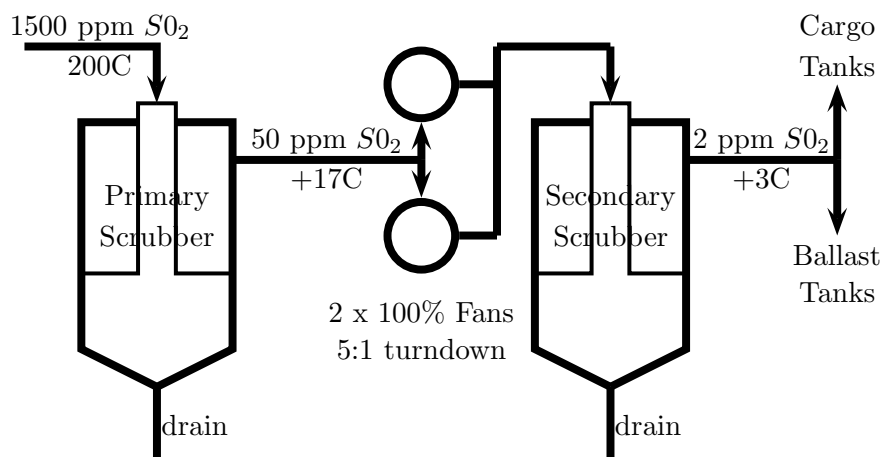
Figure 6.1: Double Scrubbing Schematic

The reason why the second scrubber is so effective is that it reduces the stack gas temperature from about 17C above seawater to only 2 or 3C above seawater as shown in Figure 6.1.¹⁷ This condenses a very large portion of the water vapor in the gas which in turn pulls out most of the remaining sulfur.

¹⁷ Figure 6.1 is based on full cargo discharge rate which for a VLCC will be about 15,000 cubic meters per hour. When the ballast tanks are being inerted, the deballast rate is normally 4,000 cubic meters per hour or less. At these rates, the SO_2 content of the double scrubbed gas will be less than 0.3 ppm.

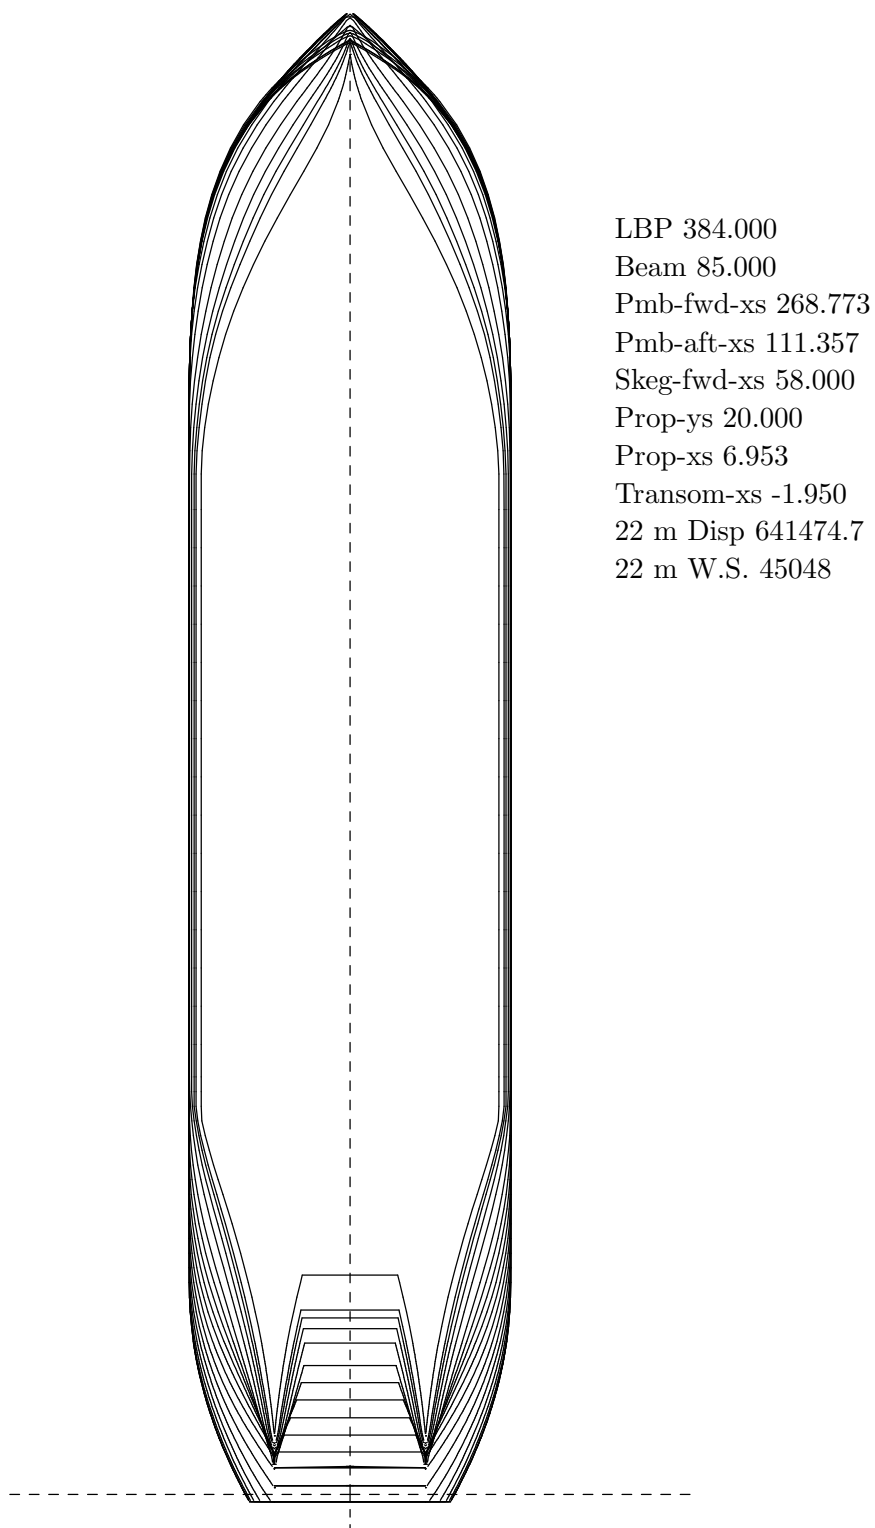
Figure 6.2: Twin Skeg Hull Form

Bystedt solved this by utilizing a *twin skeg* design. An example is shown in Figure 6.2. In effect, each propeller has its own hull. Properly implemented, the flow into the propellers is as good as that for a well-designed single screw stern. But the ship can be much beamier. For the same deadweight, this means a shorter ship which generates important savings in hull steel. It also partly compensates for the additional wetted surface of the twin screw. And it results in a shallower draft ship, allowing larger cargoes into draft limited ports.²⁸ Finally, the propellers are more lightly loaded which increases the propeller efficiency.²⁹

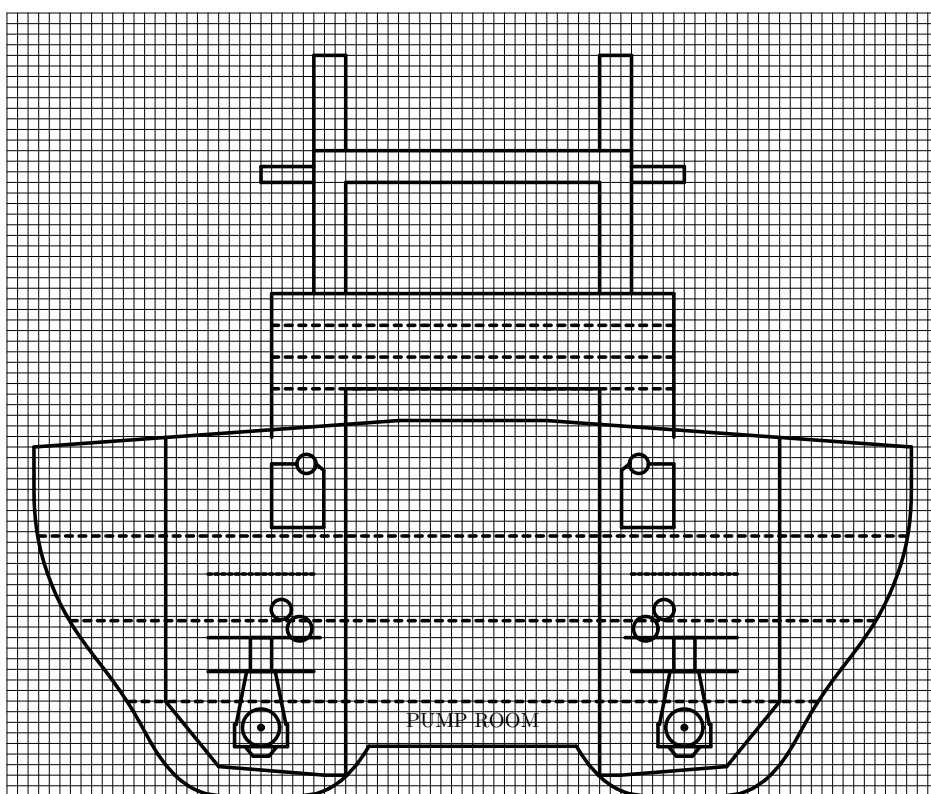
Figure 6.3: Section at Aft End of Pump Room

But for a twin skeg ship, the wording does not match the intent. Figure 6.3 shows the problem. In a twin skeg design, there is a sort of ramp between the skegs. This ramp extends from the transom down and forward. The angle and curvature of this ramp is critical to the hydrodynamic performance of the twin screw. When the ramp reaches the forward end of the engine room (the aft end of the pump room), the situation looks like Figure 6.3. The ramp is still well over 2 meters above the baseline. (In Figure 6.3, the baseline is the bottom of the drawing.) No problem. The cargo pumps in the pump room are above the inner bottom in the tanks. The ramp continues forward and downward until it finally merges with the outer bottom.

However, putting a 2 meter double bottom under the pump room causes a serious problem, because the cargo pumps must be just above the level of the inner bottom in the cargo tanks to properly empty the tanks. (Figure 6.3 like all good twin skeg designs pushes the pump room bottom as high as it can and still have the cargo pumps at the correct height.) The double skeg designer has only two choices in complying with the new pump room inner-bottom rule:

was to guard against a two meter penetration from the baseline. The drafters of the double hull legislation had not anticipated the re-entrant hull form of the twin screw. The twin screw can live with the original double hull legislation drafted in the very early 1990's. It only means lifting the inner bottom somewhat in the aftmost cargo tanks at a slight loss in capacity and structural robustness. Stupid, useless, but not a show-stopper.

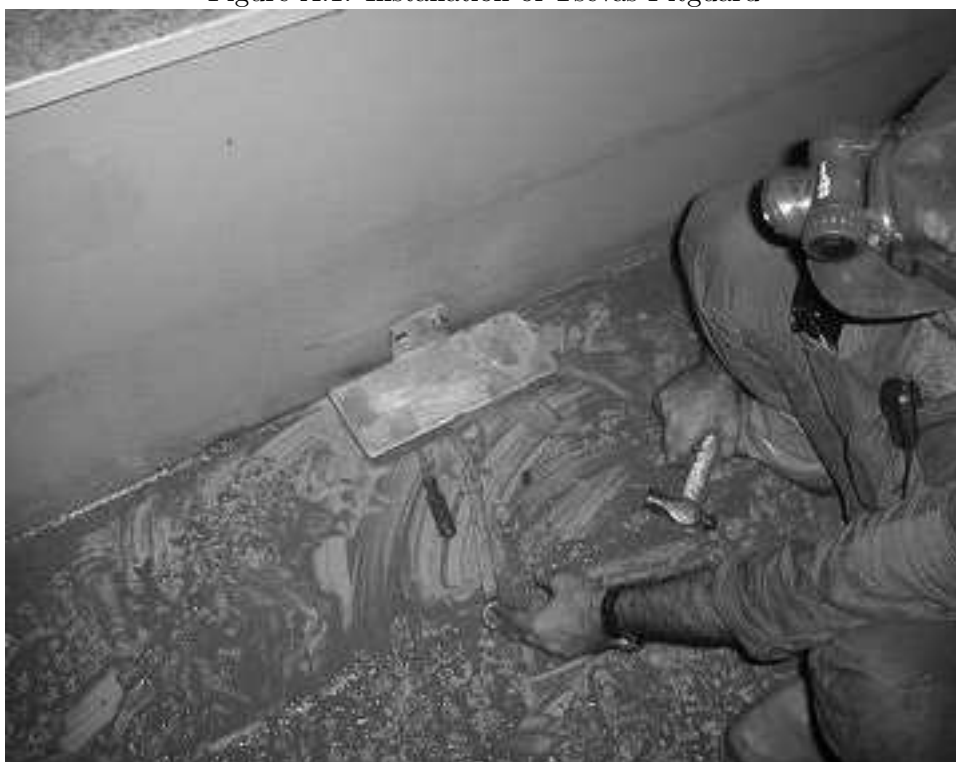
Figure A.1: Installation of Tsevas Pitguard

The normal anodes can do nothing about this layer of water, since they will not be immersed. To protect the bottom of the ballast tank we need a special kind of anode called a *pitguard*. Figure A.1 shows the system Hellespont uses. The key is to get the bottom of the pitguard right on the

bottom of the tank, so that at least some of the zinc is always immersed.

But this means the pitguards cannot be installed by the yard. The yard prefers to install anodes before painting, tape them up, and then spray. This is a good system, since it avoids the coating damage associated with installing the anodes. But it can't be used for pitguards. The pitguard would interfere with coating the bottom.

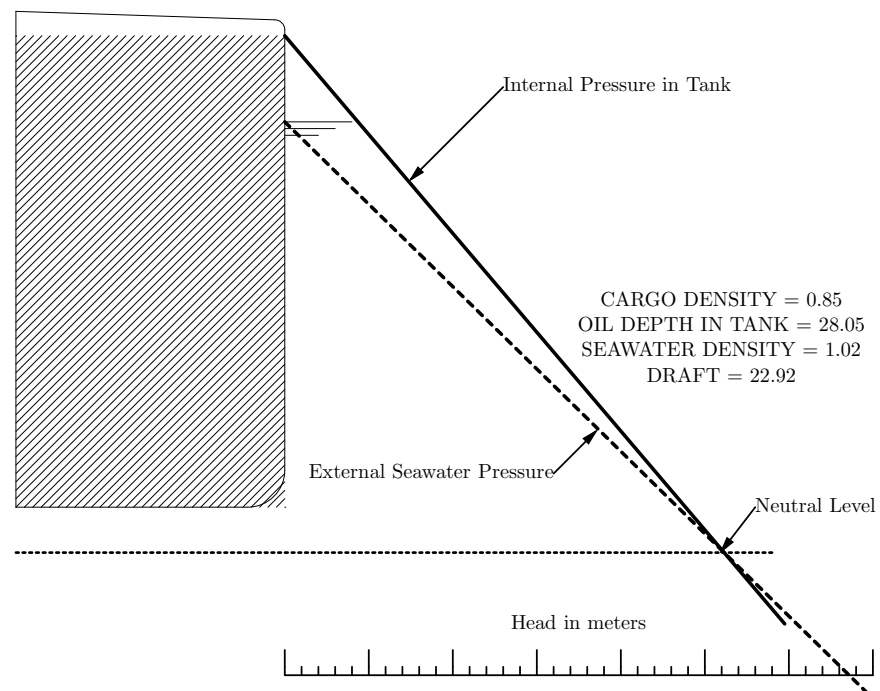
NEUTRAL LEVEL IS 2.7 M BELOW KEEL

Hydrostatic outflow from damage anywhere in the tank including flat bottom

In Figure C.1, the Neutral Level is 2.7 meters *below* the keel. This means that even at the very bottom of the tank the internal oil pressure is higher than the external seawater pressure. Damage anywhere in the tank, even at the very bottom, will result in a spill. Oil will flow out of the tank until the internal and external pressures at the top of the damage have equalized.

³ Another less important, but still very significant qualification. All tanker cargo tanks are normally inerted. That is, they are pressurized with low O_2 gas from the ship's boilers. This prevents explosions. But it also increases the pressure in the top of the tank. Typically, this increase in pressure is equivalent to about a half-meter of sea water. The solid line in Figures C.1 and C.2 actually starts off about a half-meter higher than I have

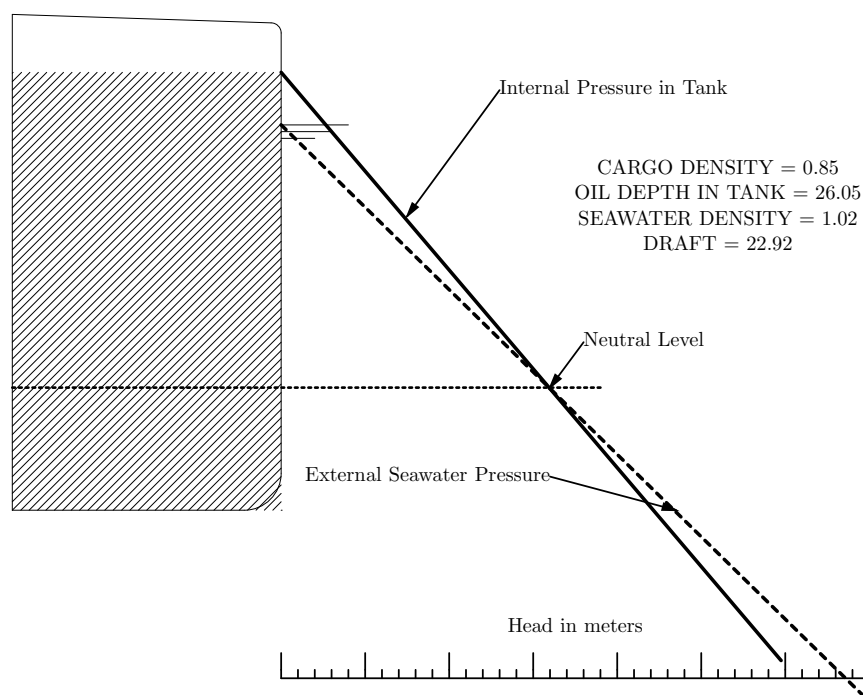
Figure C.2: Neutral Level for same ULCC, Tank Drawn Down 2 M

Now suppose we draw down the initial level of cargo in this tank 2 meters. Figure C.2 shows the new situation, assuming the ship remains at the same draft. The oil has lost a considerable portion of its head start; and the

NEUTRAL LEVEL IS 7.3 M ABOVE KEEL
No hydrostatic outflow from damage below Neutral Level

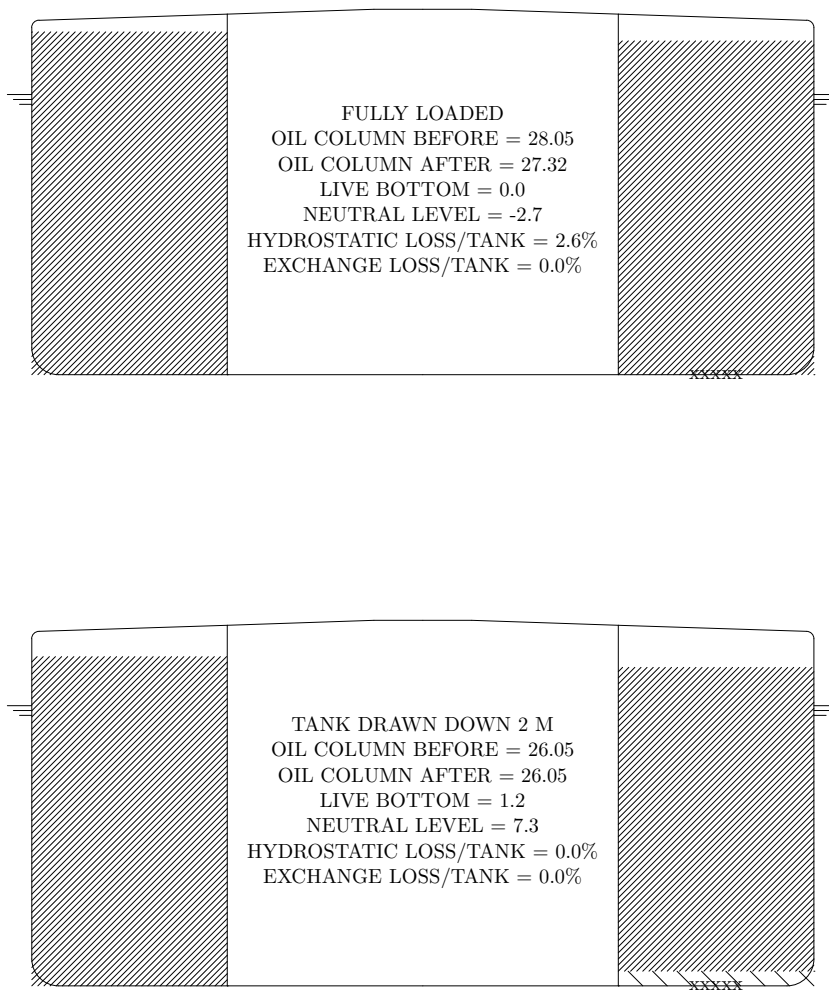
Figure C.3: Final situation, Full load vs Tank Drawn Down 2 M

The bottom half of Figure C.3 says we only had to underload such ships by about 7%, and they would have spilled nil oil if the damage is limited to the bottom. (Once again I'm assuming the underloading was accompanied by sufficient ballast to keep the ship at the same draft.)

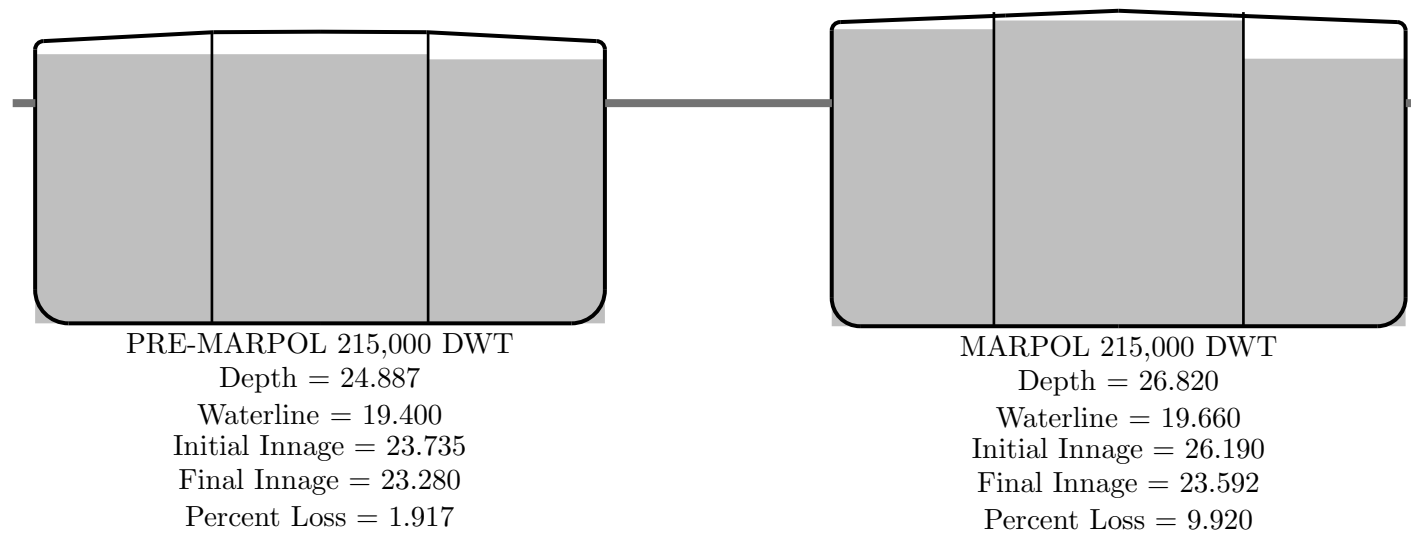
Figure C.4: Marpol vs pre-Marpol Spillage

BOTTOM DAMAGE TO TANK ON THE RIGHT
