The Tankship Tromedy

**The Impending Disasters in
Tankers**

Jack Devanney
Sisyphus Beach
Tavernier, Florida

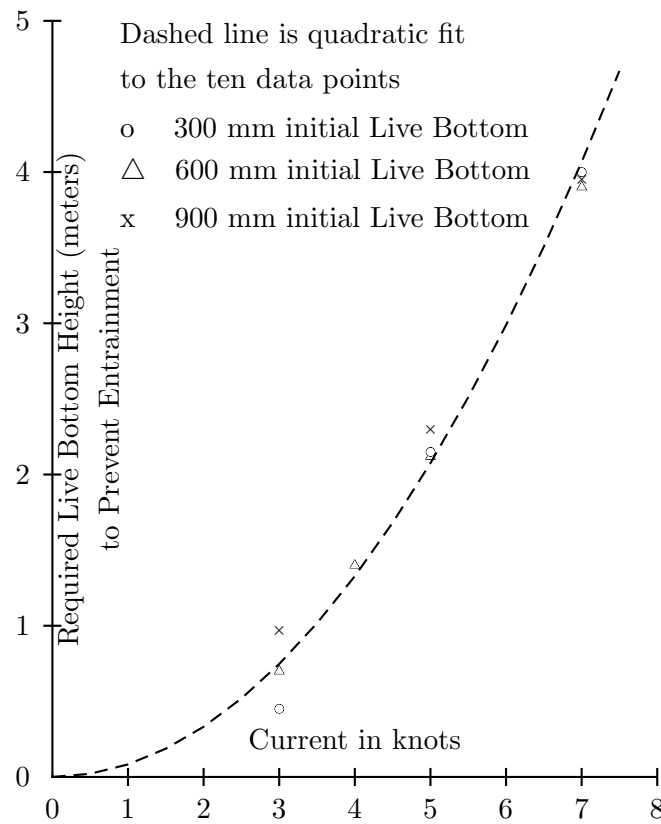
Figure C.5: Required Live Bottom Height versus Current Speed

and, for a high enough Live Bottom, even the trough in the wave is above the ship bottom, at which point current loss effectively halts. As Figure C.5 indicates for a three knot current, the Live Bottom has to be about 0.7 meters above the real bottom.¹⁰ For a 5 knot current, we need about a 2.2 m Live Bottom height. The required Live Bottom height goes as the square of the current velocity as would be expected from Bernoulli's Law.

I would not make too much of Figure C.5 for two reasons:

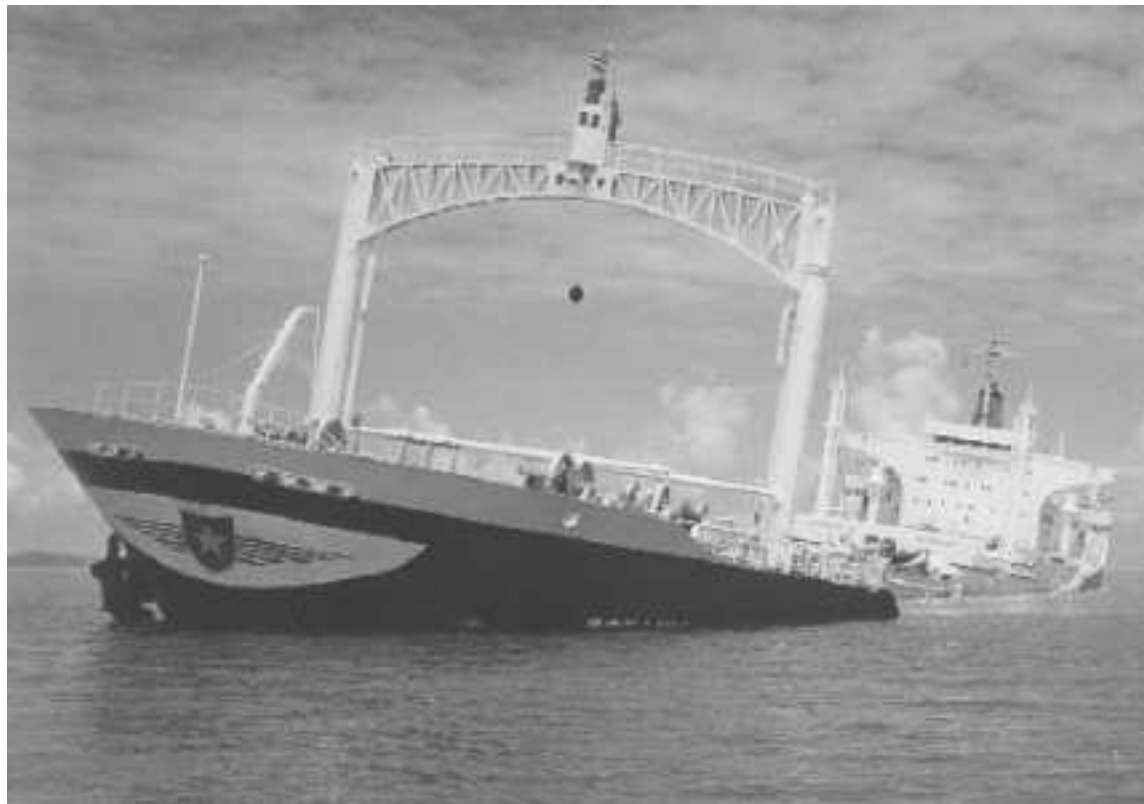
Figure C.6: Oceanic Grandeur after flooding. Hull is under extreme sagging moment but survived. No new tanker would. Note the extremely strong kingposts and the rare forward crowsnest, signs of an unusually well-specced ship. Source: Australian Maritime Safety Authority.

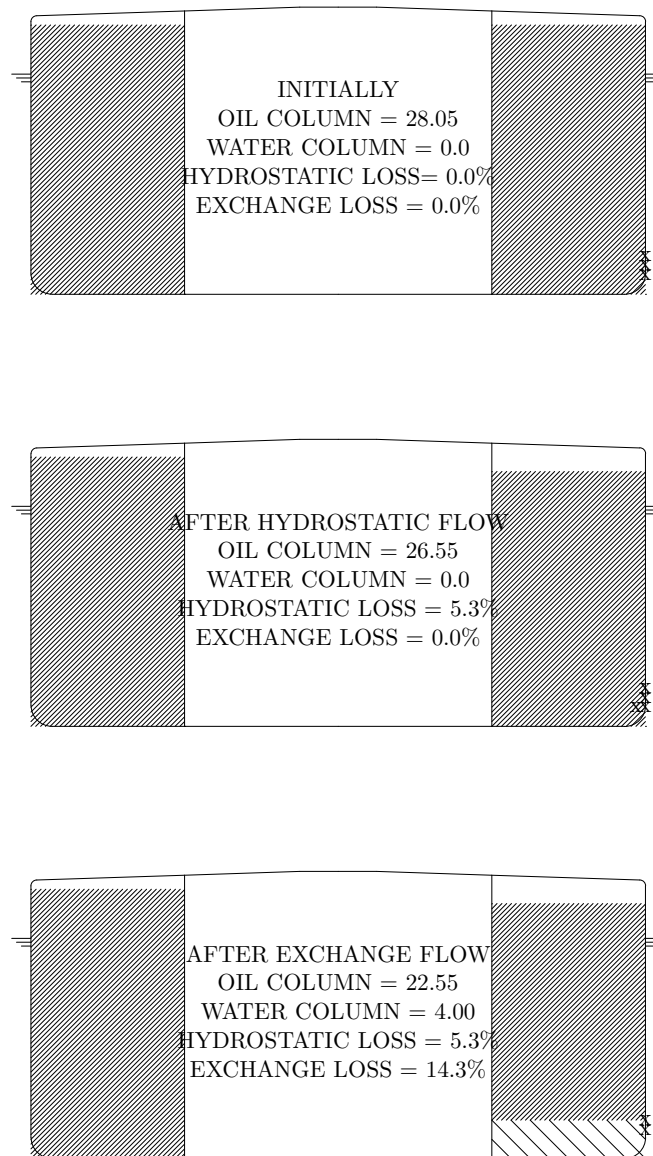
Figure C.8: Fully Loaded, Pre-MARPOL, Side damage up 4 M

only 2.6% of the tank to hydrostatic flow.

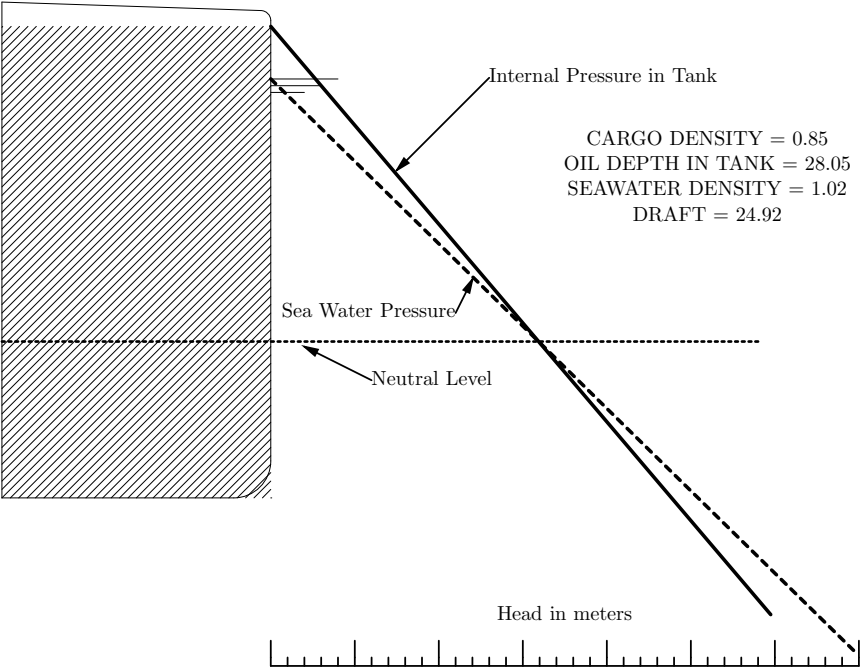
Figure C.9: Full load but ballasted down 2 M

NEUTRAL LEVEL IS 9.3 M ABOVE KEEL

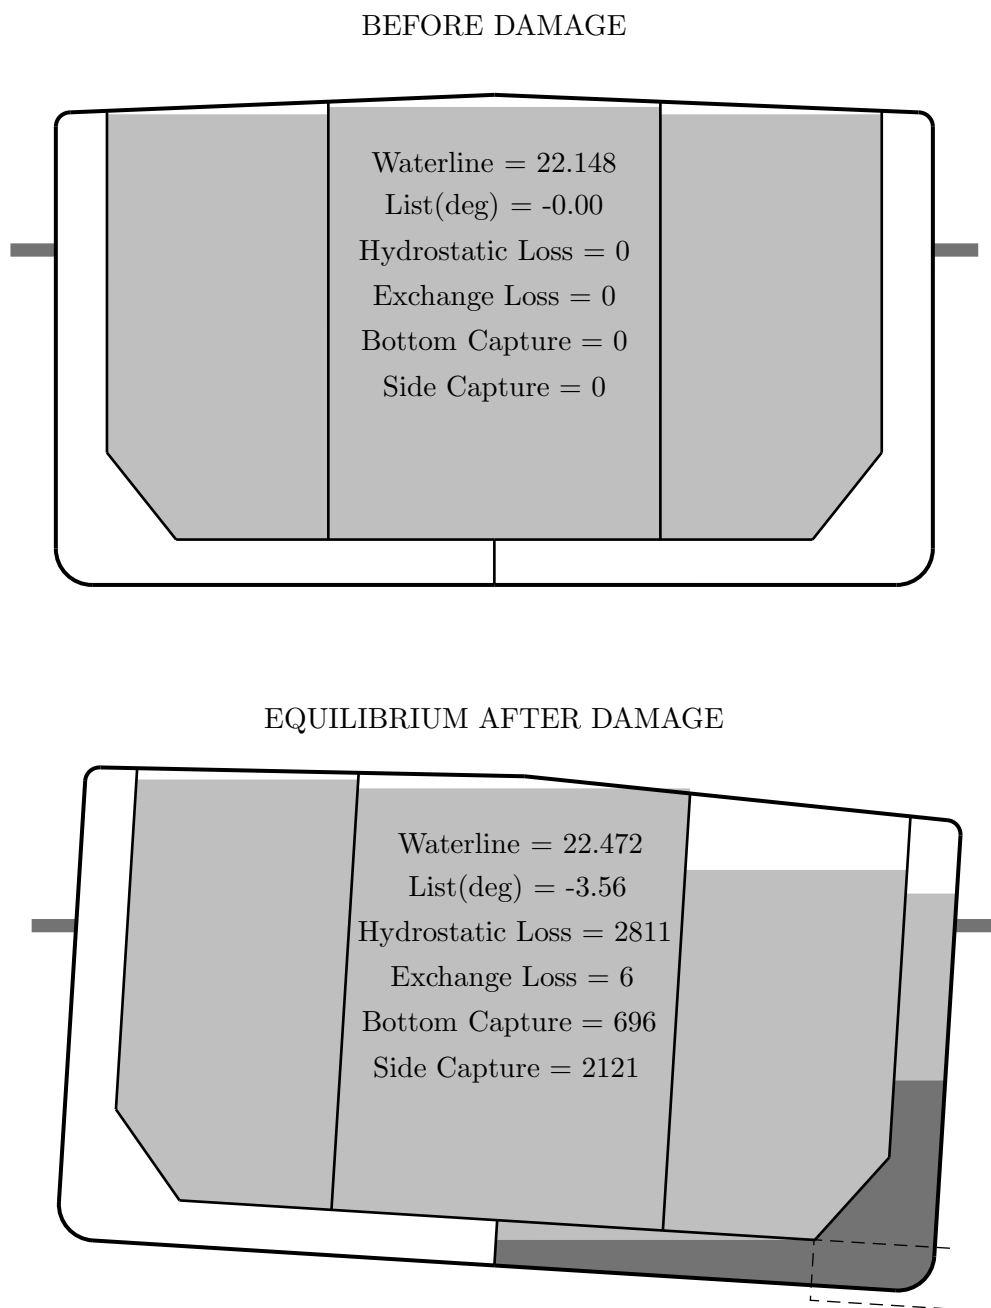
Figure C.12: Damage at hopper corner. Light gray is cargo. Dark gray is seawater.

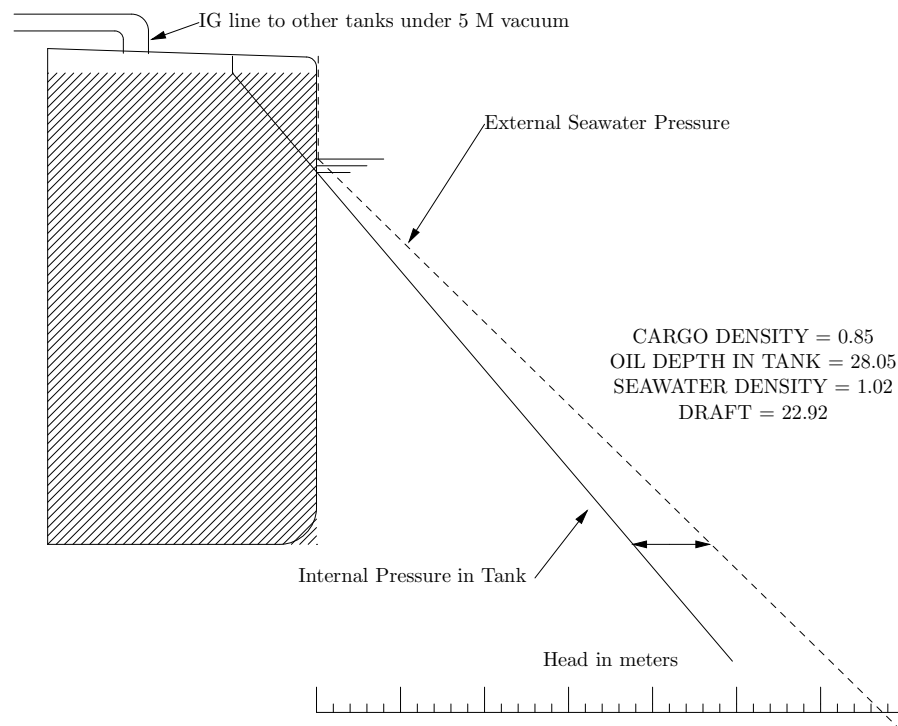
Figure C.14: Active Full Vacuum(5M) Tanker, Full Tank

You are right. ***The damaged tank will automatically pump itself out to the undamaged tanks.*** This transfer will begin immediately upon damage with absolutely no intervention from anybody. Please re-read the last two sentences. The increase in pressure at the bottom of the damaged tank — indicated by the double arrow in Figure C.14 — will push cargo through the IG lines to the other tanks. In the situation shown in Figure C.14, seawater will push an amazing 17 meters into the tank as long as there

NEUTRAL LEVEL IS ABOVE THE TOP OF THE TANK
Internal pressure is lower than external pressure at all levels

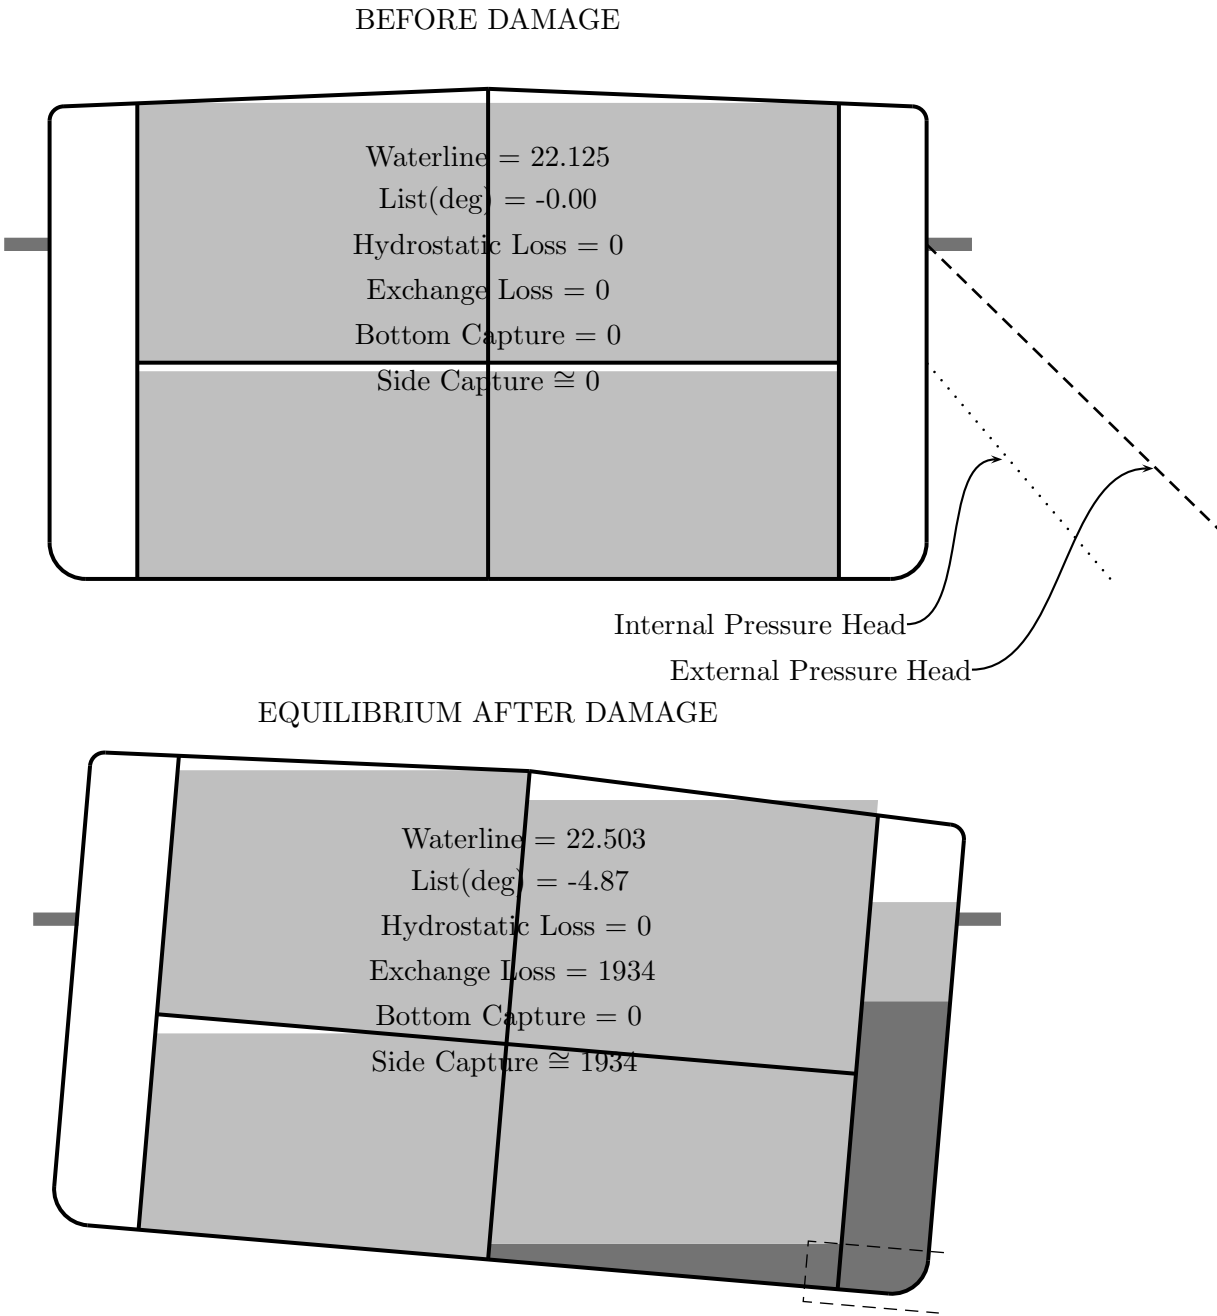
Figure D.1: Mid-Deck, Damage up 3 m. Light gray is oil, dark gray is seawater

The concept has excellent ability to withstand an ebb tide. Even after a 3 m drop in the tide, such as that experienced by the EXXON VALDEZ, the hydrostatic balance is still 7 meters in our favor. ***If the Exxon Valdez, had been a Mid-Deck ship, she would have spilled very little oil.***

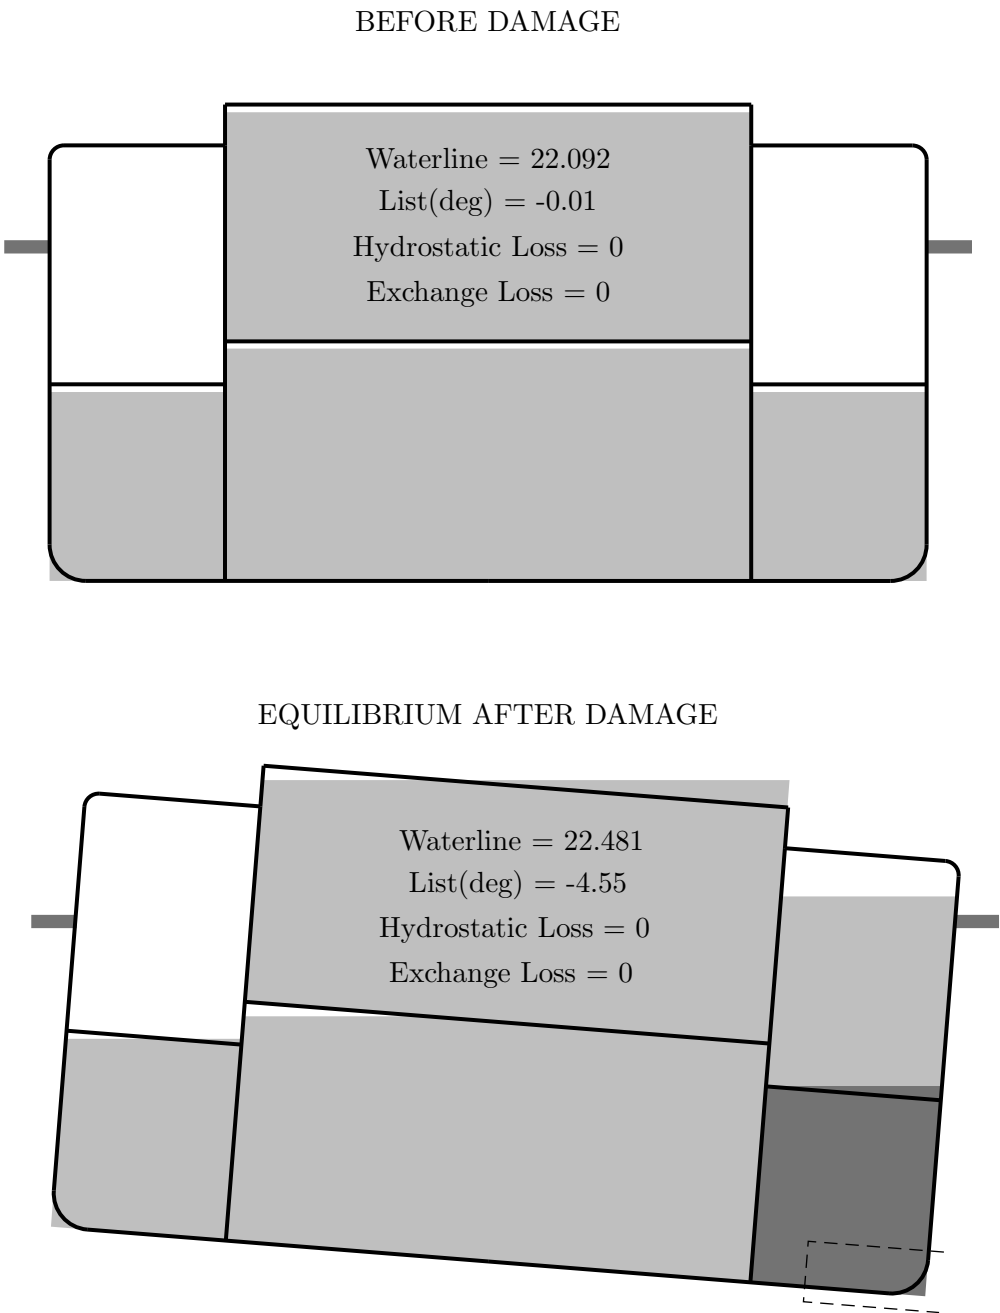
Figure D.2: Coulombi Egg, Damage up 3 m. Light gray is oil, dark gray is seawater

The Coulombi Egg is a mid-deck design, but the ballast tanks are set above the outboard cargo tanks as shown in Figure D.2. The lower tanks are connected to these ballast tanks by non-return valves. When a lower tank is damaged, the incoming sea water pushes the oil in the damaged tank up into the ballast tank. There is an automatic transfer out of the damaged tank much like the active full vacuum ship. If the damage is near the bottom of a lower cargo tank, the Live Bottom will end up about 9 m above the ship bottom well protected from current, wave action and ship motion. But what I really like about the Egg is that **a VLCC built to this design will have only 66,000 m² of ballast tank coated area, and less than 20,000 m² of cargo tank/ballast tank interface area.** Ballast tanks properly inerted, the Egg is about as good as it gets in terms of minimizing ballast tank explosions on a segregated ballast tanker. Notice also that you can use air to blow out the damaged tank without putting any oil in the water. This can be a big help in refloating the ship. (This description of the Egg is not quite up-to-date. IMO in its wisdom required some changes to the original design which in my opinion degraded the performance of the concept.)

² My favorite is the unfortunately named Coulombi Egg. The Mid-Deck does a poor job of using its favorable hydrostatic balance to move the oil away from the damage. The small vertically oriented ventilation pipes take only a small amount of oil before the equilibrium will be established. This puts the Live Bottom interface close to the real bottom where it could be subject to current, wave-pumping, vessel motion, and the like.
